# ***Lessons Learned From Structural Failures***

*Presented by:* **Clifford Schwinger, PE**

**October 15, 2019 DVASE Breakfast Presentation**

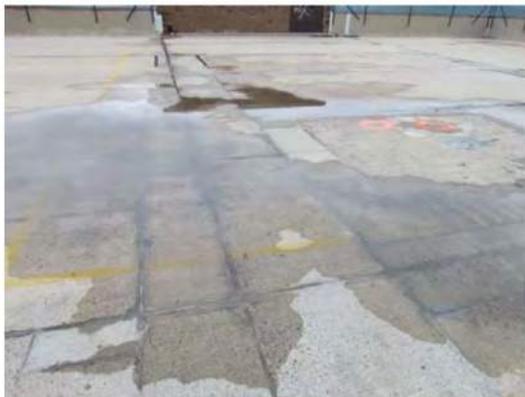
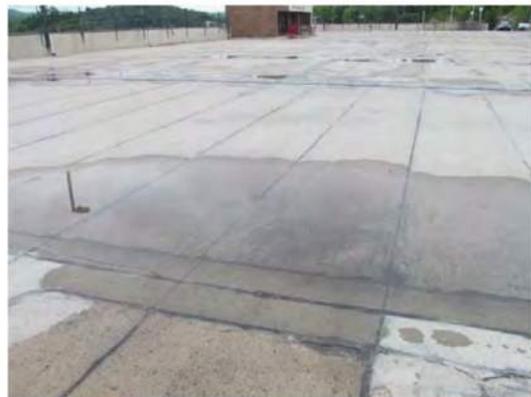
Ponding on roof (insufficient slope for drainage).

Figure 4-5 - Ponding observed during on-site investigation (a) Along gridline C facing North (b) At gridline 11 facing South

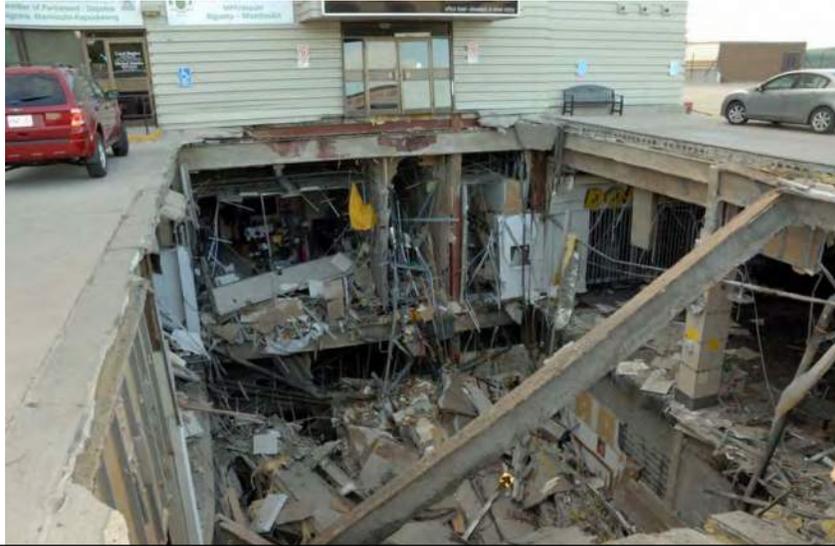
- June 2012: Two bays collapse - killing two.
- Collapse caused by failure of corroded beam-to-column connection.

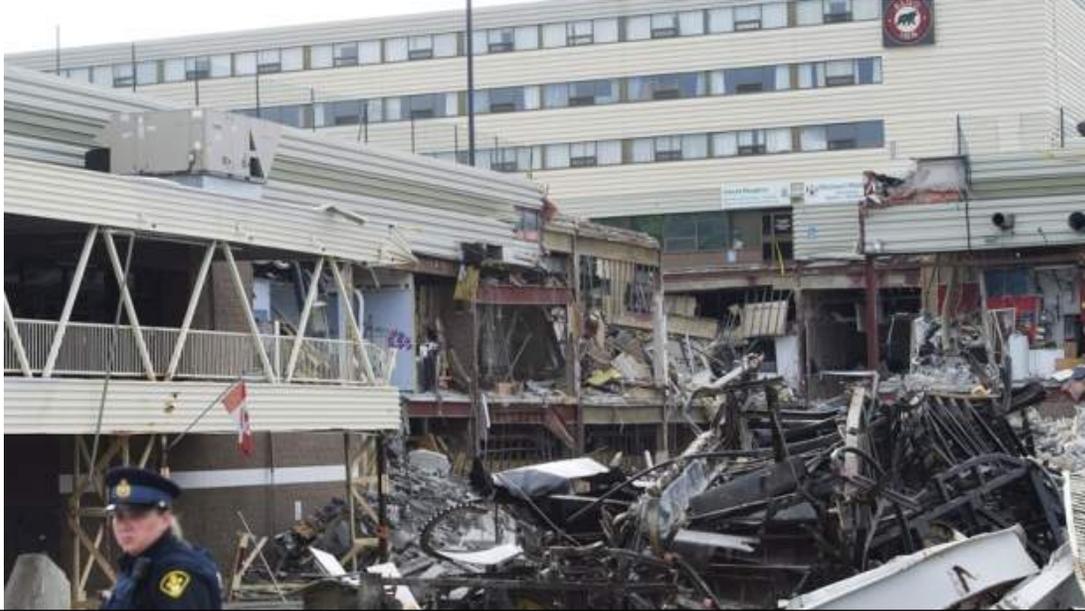
Two bays of framing collapse in June 2012 – killing two.

- March 2013: Forensic report issued. Collapse was caused by a failure of a welded connection due to corrosion. Corrosion caused by improper waterproofing and placement of parking deck on roof, which allowed salt-laden water to corrode the structure.
- Original engineer and architect testified they objected to the rooftop parking, but the owner did not listen.

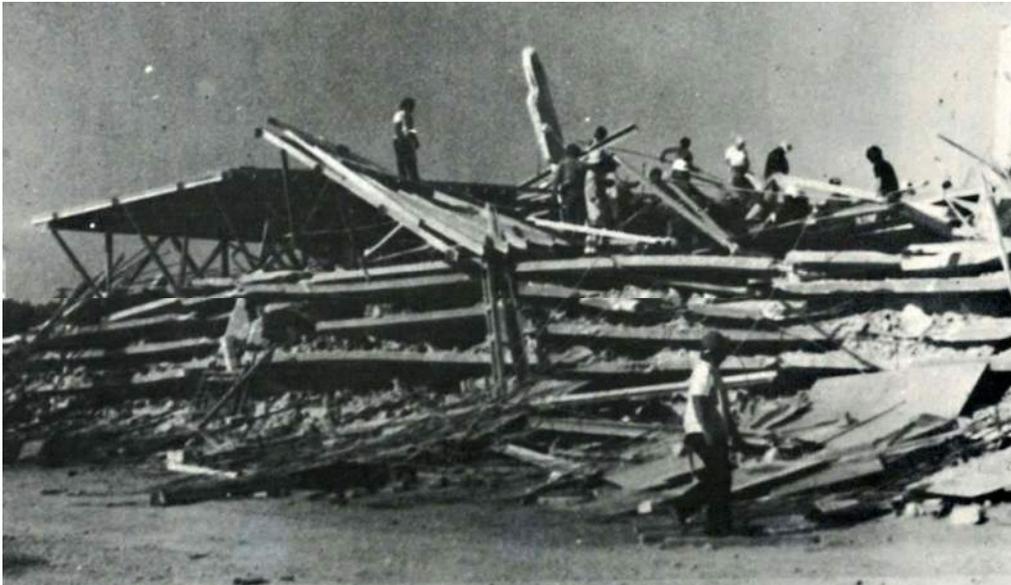
Structure collapses March 1981 as roof slab is poured – killing 11.

- Structural design: Only 78 pages of calculations.
- 10"x18" columns too small for punching shear.
- Punching shear not checked (punching shear overstresses).
- Top bars placed 1" too low (reducing "d"; reducing punching shear strength)
- Engineers seemed to be working outside their area of expertise
- Both engineers lost their licenses

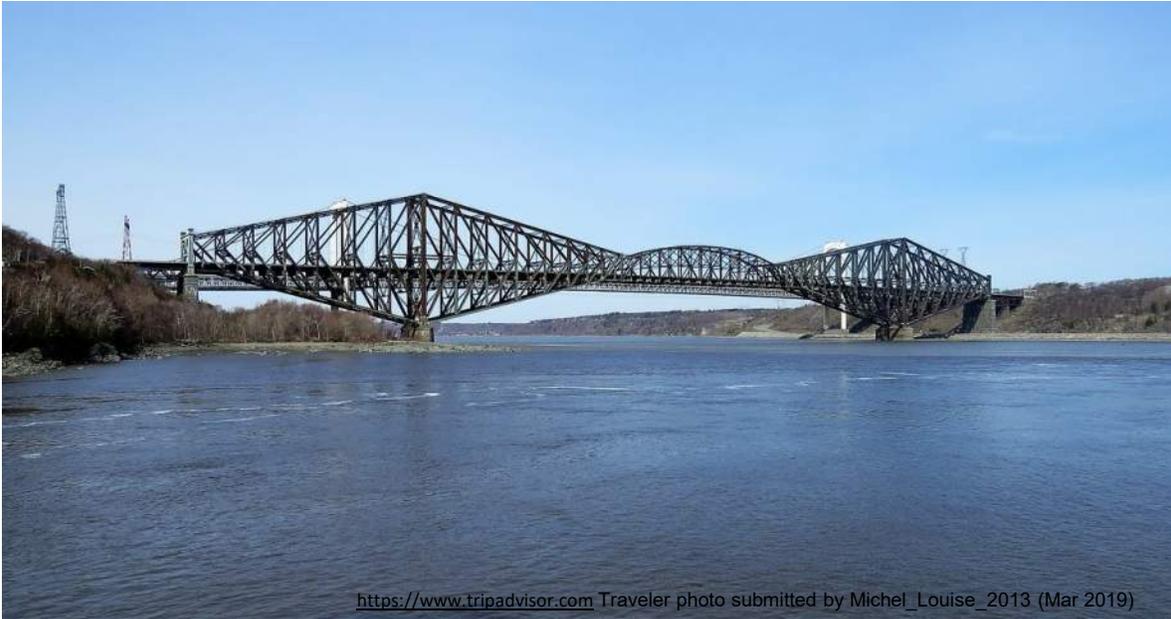
Bridge today (weighs 2.5 times more than original.)

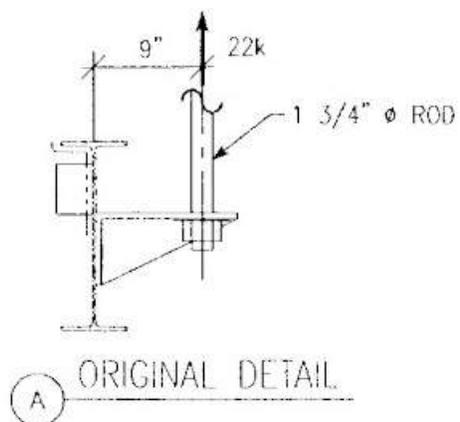
- Mid 1978: Hanger connection issued with eccentric connections

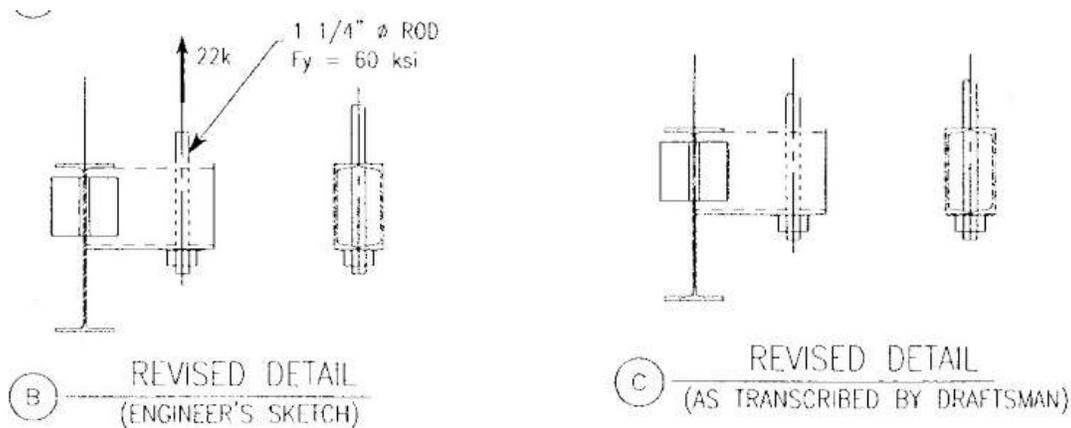
- Mid 1978: Hanger connection revised using double channel and 60 ksi single rod hanger. 22k reaction shown on sketch.

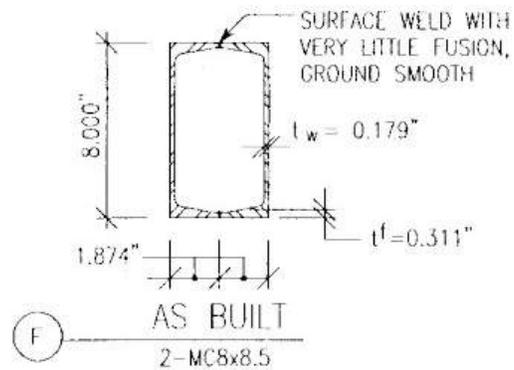
Original double channel detail was seriously overstressed.

Strength ratio = 1.67

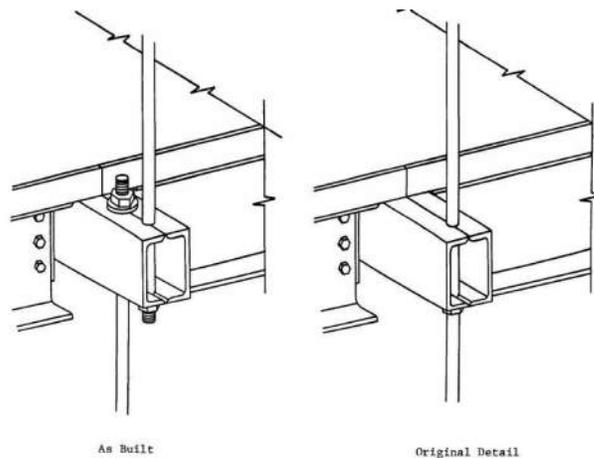
Figure 10.2 Comparison of interrupted and continuous hanger rod details.

Revised detail increased hanger reaction from 22k to 44k on outer hanger.

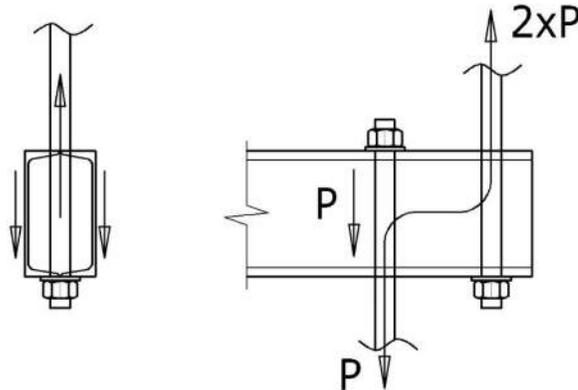
Strength ratio of revised detail =  $3.23 \gg 1$  (no good!)

One kink in original connection; Three kinks in revised connection.

Overstress in revised connection detail: Strength ratio =  $1/0.31 = 3.23$

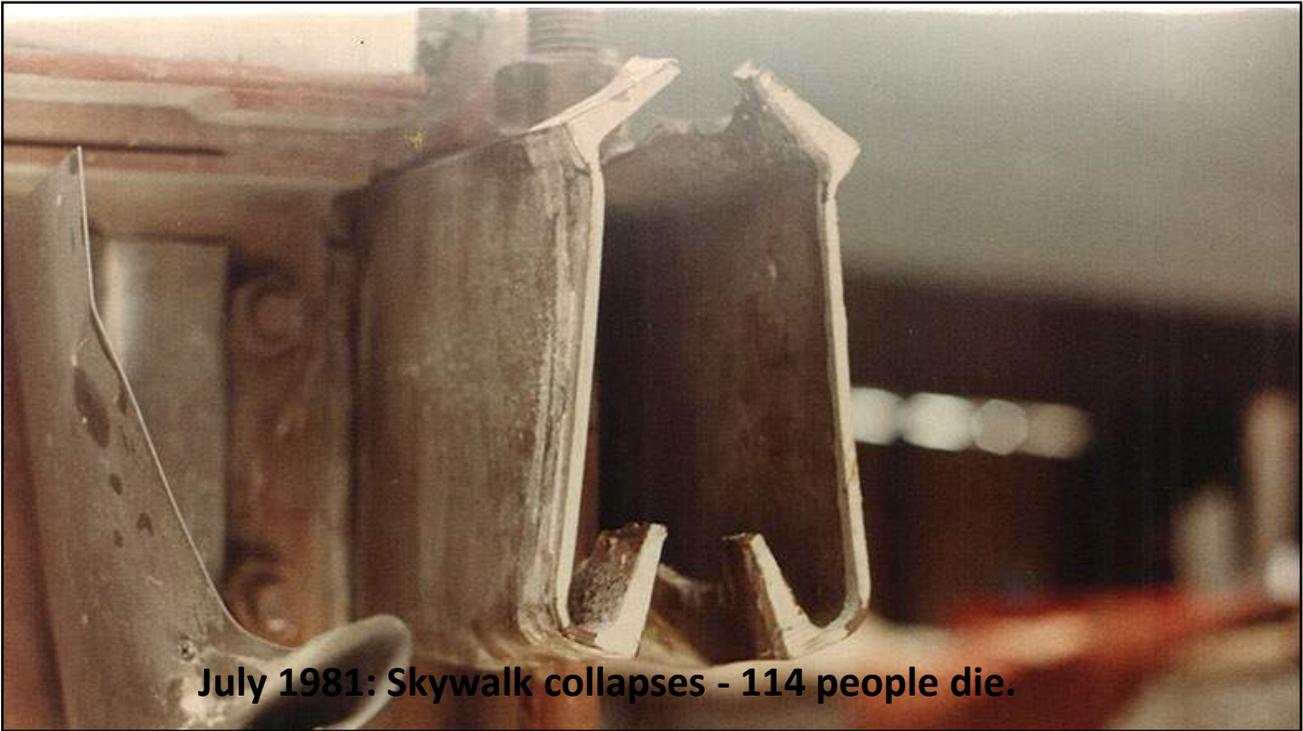
**July 1981: Skywalk collapses - 114 people die.**
