DVASE 2021 Excellence in Structural Engineering Awards Program

Confidential Client Vertical Expansion - Urban Jenga 10 Stories Up, Without a Crane:

The Vertical Expansion project is a 52,000 SF two-story vertical connector addition occupying a plan footprint of 115'x45' and is elevated one story above the existing Level 10 roof of the original 1970s Main Hospital construction. Flanking the full length of both the east and west sides of the addition are two existing skylights and public space atria below. The north and south ends of the connector are bracketed by taller portions of a 2003 Hospital addition. Additionally, there was an existing concrete and steel framed helipad located within the footprint of the new connector addition that was partially removed and partially integrated into the new structure.

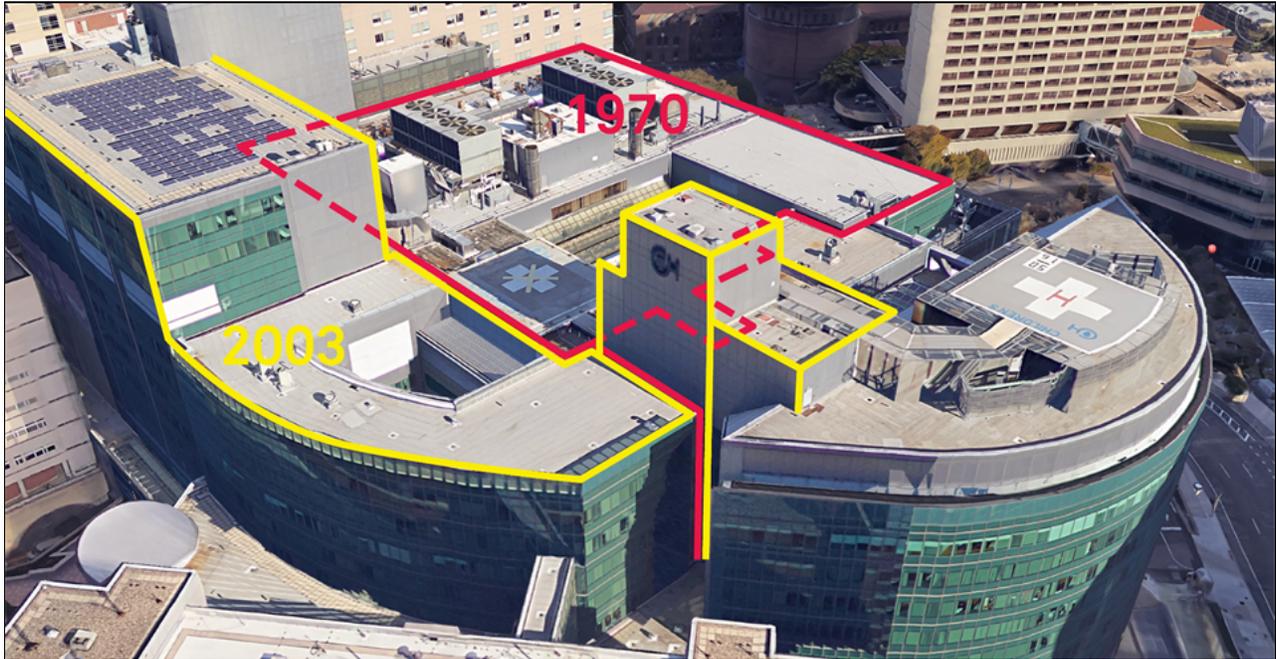
EXISTING MAIN HOSPITAL
(ORIGINAL 1970s MAIN HOSPITAL IN
RED; 2003 ADDITION IN YELLOW)

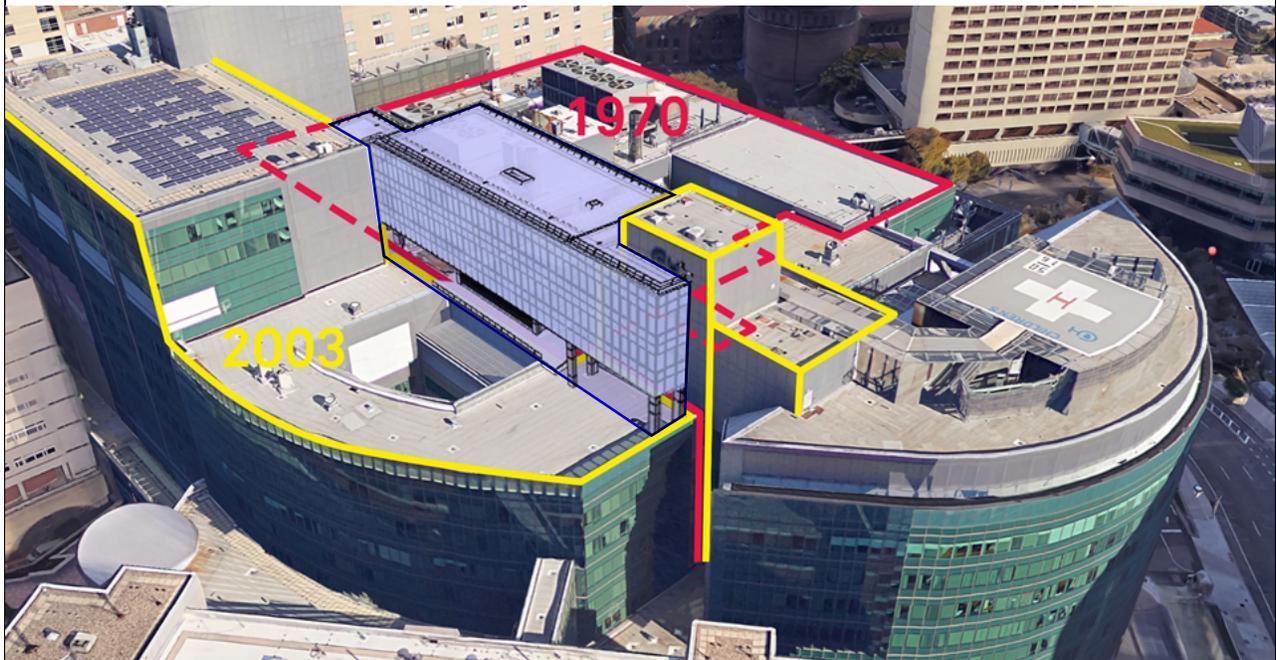
EXISTING MAIN HOSPITAL WITH
NEW ADDITION
(NEW ADDITION HIGHLIGHTED IN BLUE)

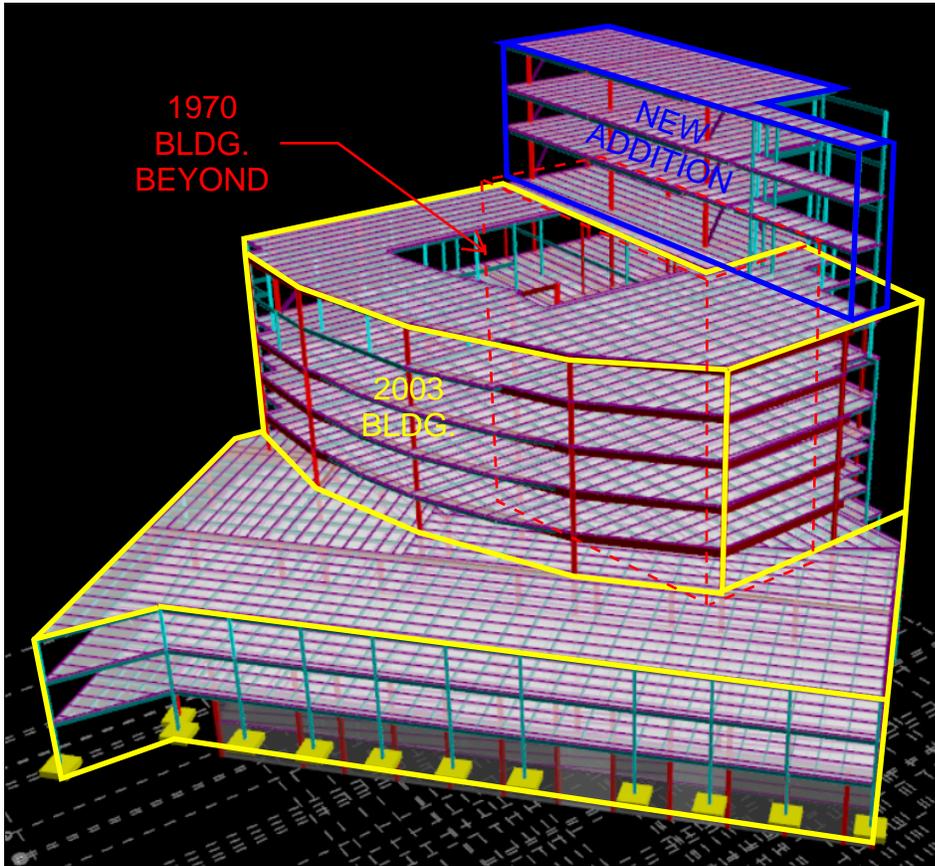
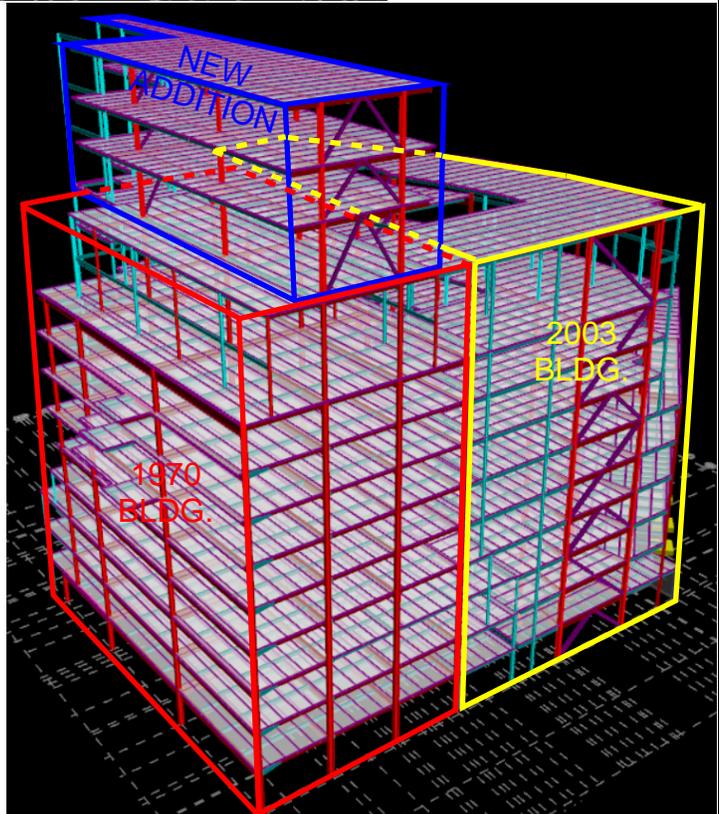
RAM STRUCTURAL SYSTEM
MODEL VIEWS:

TOP: VIEW FROM SOUTHWEST

RIGHT: VIEW FROM NORTHEAST

- **Existing Building Modeling**: Large portions of the existing 1970s and 2003 buildings between expansion joints were modeled to evaluate the effect of new connector and construction loads on existing structures. The structural model was made in RAM Structural System and originally used to determine the extents of required reinforcement of the existing structures due to the added load of the new connector. As the pre-construction and construction phases of the project progressed, the model was also used to evaluate several construction loading conditions in combination with different levels of completeness for the new structure. This allowed Ballinger and the contractor to balance the construction and new structure loads, such that construction could remain on schedule while the reinforcement of the existing structure below was coordinated and performed in overnight shifts to avoid interrupting hospital activities. The entire project would have been significantly delayed if the contractor had to wait until all reinforcement of the existing structure was completed before starting construction activities for the new connector.

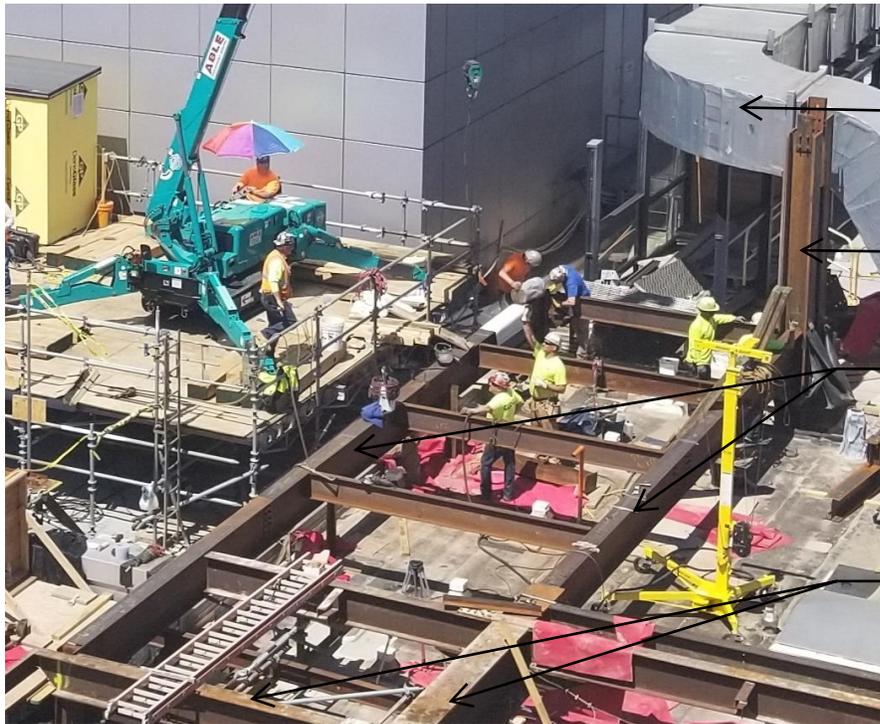
STEEL FRAMED WORK PLATFORM CONSTRUCTION

EXISTING DUCTWORK TO REMAIN UNDER NORTH END OF CONNECTOR THAT PREVENTED ERECTION FROM LOW ROOF - JIB CRANES FROM 2003 ADDITION USED IN THIS AREA

NEW BUILDING COLUMN SUPPORTING TEMPORARY WORK PLATFORM

TEMPORARY STEEL FRAMING FOR WORK PLATFORM

EXISTING HELIPAD STEEL FRAMING REUSED AS WORK PLATFORM SUPPORT FRAMING

- **Steel Framed Work Platform**: The limited live load capacity of the existing 1970s roof, which is directly below the connector addition, necessitated a new steel framed work platform, supported by the existing columns, that could support the construction loading. The new temporary work platform was built a few feet above the existing roof and at the same elevation as the existing helipad. This allowed the new steel framing of the platform to be spliced together with the existing helipad steel framing to create one large working surface for material staging/handling and erection of the structure using Maeda mini-cranes. New connector columns were also used to support the working platform on the existing columns. Material staging and location of mini-cranes on existing helipad steel framing was evaluated by Ballinger and crane locations were limited to avoid excessive loading on the existing helipad cantilevered framing of the east and west sides.

- **Connector North End Erection**: Erection of the north end of the new connector, which connects the new structure to the upper levels of the 2003 addition, could not be performed from the existing 1970s roof due to existing ductwork that could not be removed. Ballinger and the contractor investigated the design of window washing roof davits on the 2003 addition roof and determined that they could be used in combination with jib cranes to erect the north end.

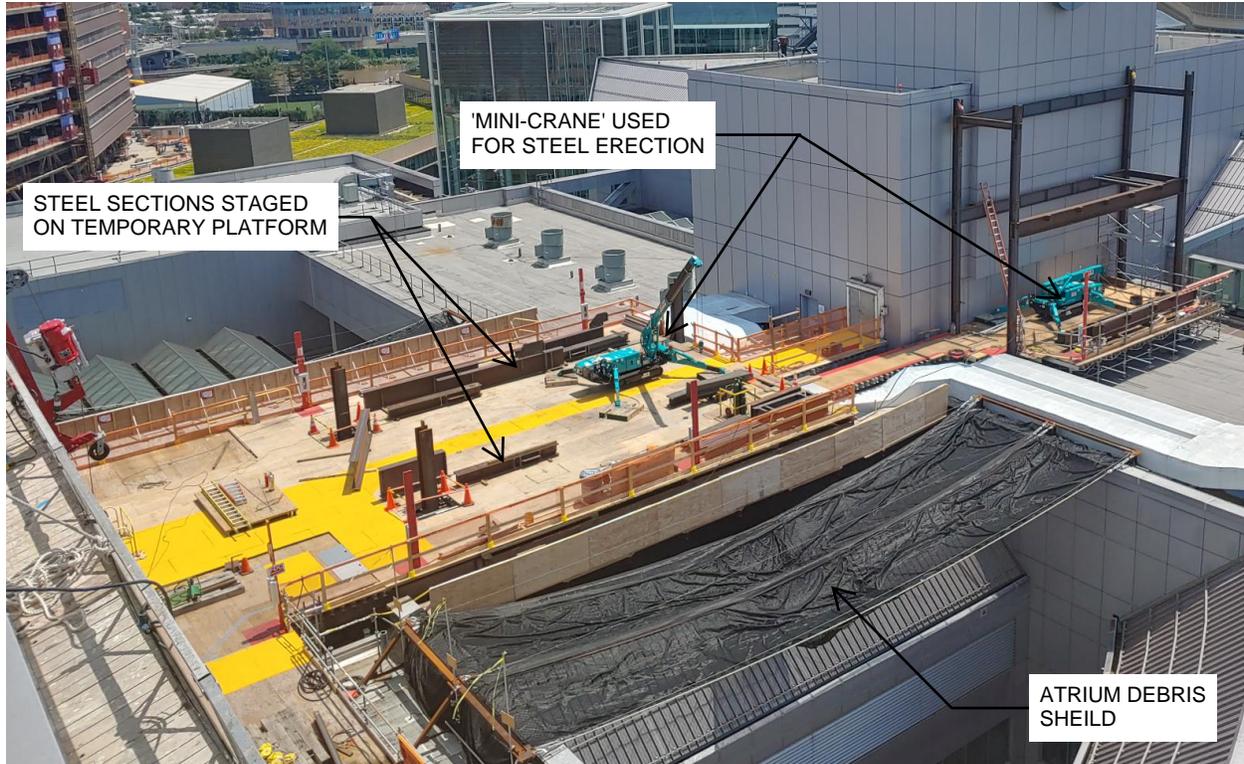
'MINI-CRANE' USED FOR STEEL ERECTION

STEEL SECTIONS STAGED ON TEMPORARY PLATFORM

ATRIUM DEBRIS SHEILD

COMPLETED WORK PLATFORM @ START OF STEEL ERECTION

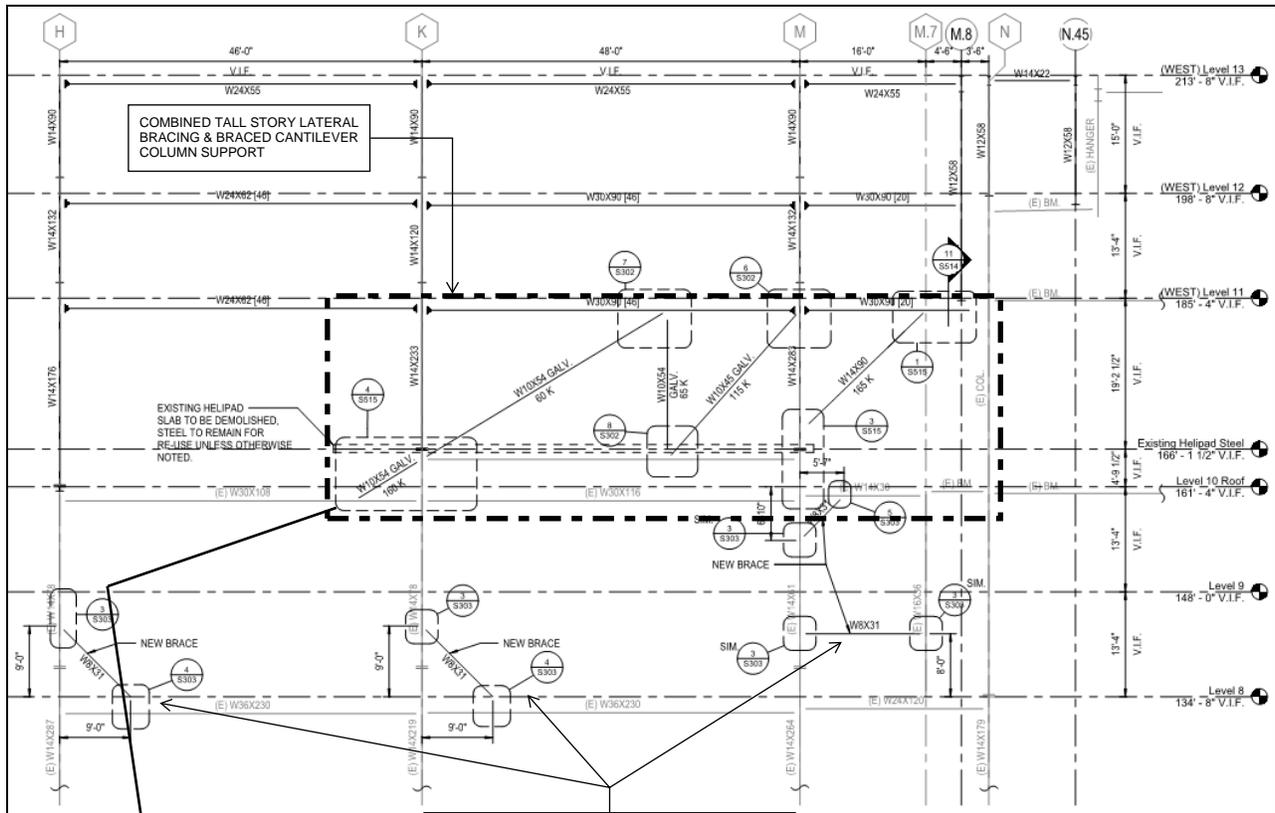
NORTH/SOUTH FRAMING ELEVATION:

COMBINED TALL STORY LATERAL BRACING & BRACED CANTILEVER COLUMN SUPPORT

EXISTING HELIPAD SLAB TO BE DEMOLISHED, STEEL TO REMAIN FOR REUSE UNLESS OTHERWISE NOTED.

NEW BRACING IN EXISTING MECHANICAL ROOM BELOW TO REINFORCE EXISTING 2-STORY COLUMNS

NEW STEEL PLATE REINFORCEMENT OF EXISTING HELIPAD COLUMNS

STEEL GUSSET PLATE TO STIFFEN & REINFORCE EXISTING HELIPAD FRAMING

EXISTING 1970s ROOF STEEL FRAMING

EXISTING HELIPAD STEEL FRAMING REUSED FOR WORK PLATFORM AND TO SUPPORT MECHANICAL EQUIPMENT

NEW BRACED FRAME CONNECTION THROUGH EXISTING HELIPAD STEEL FRAMING:

- **1970s Building Existing Column Reinforcement**: The existing 1970s building columns that supported the new connector passed unbraced through a two-story mechanical room directly below the Level 10 roof. New steel column bracing was added to the columns in the mechanical room to reduce their unbraced length and utilize the existing column strength. Locations for bracing were determined in the field through coordination with contractor, steel fabricator/erector performing the work, and existing MEP equipment inside the mechanical room.

- **Existing Helipad Steel Framing**: While reusing the existing helipad steel frame to create the working platform helped solve one challenge, it created another. It meant the existing helipad columns would also need to permanently support the new two-story connector and the new mechanical equipment located in the open story below the connector. The connection of the new columns to the existing structure were redesigned to incorporate and reinforce the existing helipad steel columns. Additionally, it was determined that the remaining helipad framing used to support the temporary work platform could also be reused to permanently support a new AHU and its associated service platform, saving valuable time and money for the project.

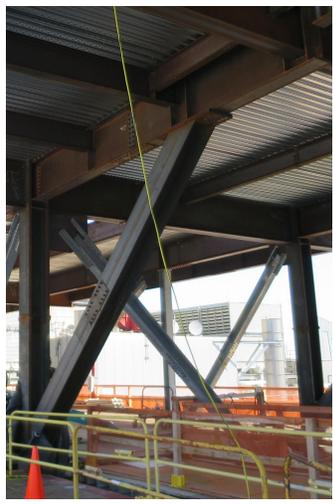
ABOVE: VIEW OF SLOPED COLUMN COMBINED W/ TRANSFER GIRDER SUPPORTING SOUTH END OF CONNECTOR

- **South End Sloped Columns**: The structural model of the existing 2003 building at south end of the connector showed it could not support additional loads from the new addition without extensive column strengthening below. To avoid the potential cost and disruption caused by such strengthening, the design team instead choose to support a 20'x45' section of the two-story connector at the south end with a combination of sloping columns and cantilevered transfer girders along the two main north/south column lines.

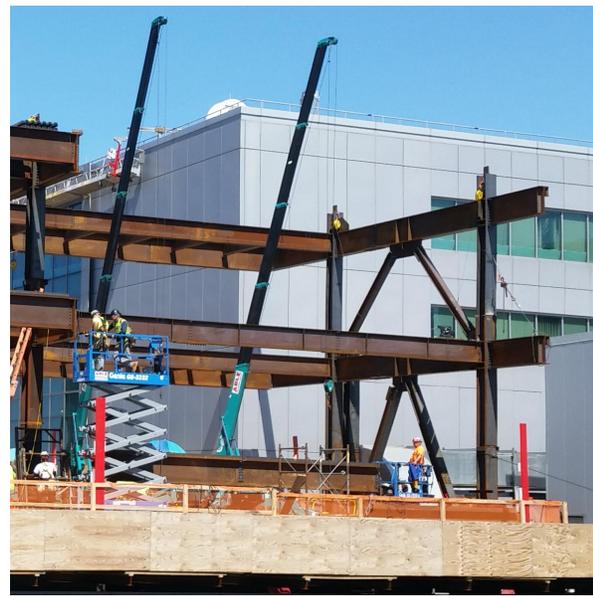
STEP #1: TWO 16'-0" SECTION SPLICED TOGETHER ON WORK PLATFORM & HOISTED INTO PLACE W/ TWO MAEDA MINI CRANES

TYPICAL ERECTION SEQUENCE OF 48'-0" LONG BEAMS :

- **Maximum material length of 17'-0"**: Limitations on maximum material length that could fit in the hoist required much of the steel framing to be field spliced, in many cases more than once. The existing grid spacing of 24'x48' required the 48' long beams to be spliced twice, while girders were spliced once at the center and also cantilevered 12' on the west side and 8' on the east side.

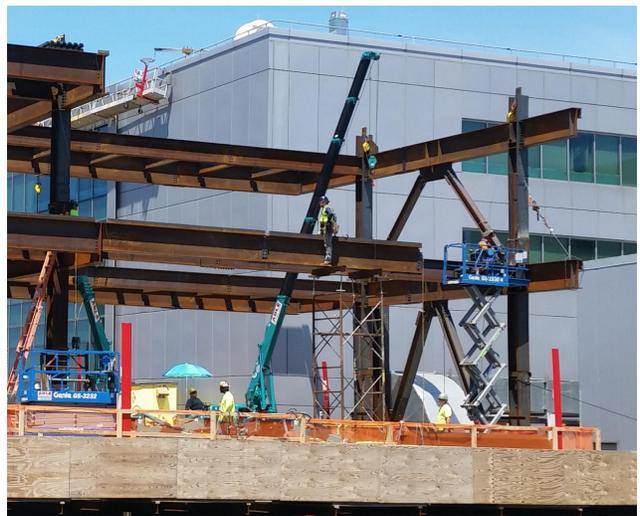
STEP #2: 32'-0" SECTION SUPPORTED BY CONNECTION ON NORTH END & SHORING ON EAST END PRIOR TO FINAL 16'-0" SECTION BEING LIFTED INTO PLACE

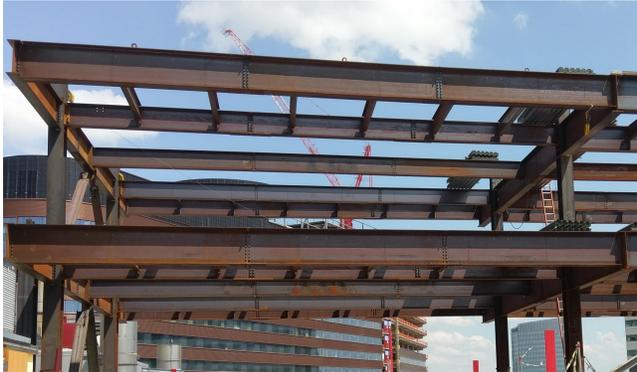
ABOVE: VIEW OF THE WEST SIDE OF THE COMPLETED FRAMING FOR 1ST AND 2ND SUPPORTED LEVELS SHOWING THIRD POINT SPLICES FOR THE 48'-0" LONG BEAMS.

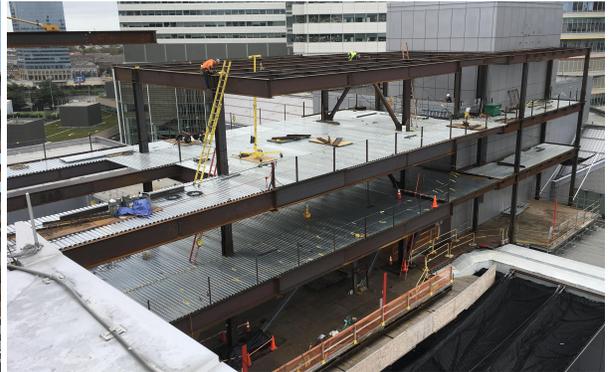
ABOVE: VIEW OF THE WEST SIDE FROM ROOF OF 2003 BLDG. SHOWING PARTIAL COMPLETION OF ROOF FRAMING AND FLOOR DECKING.

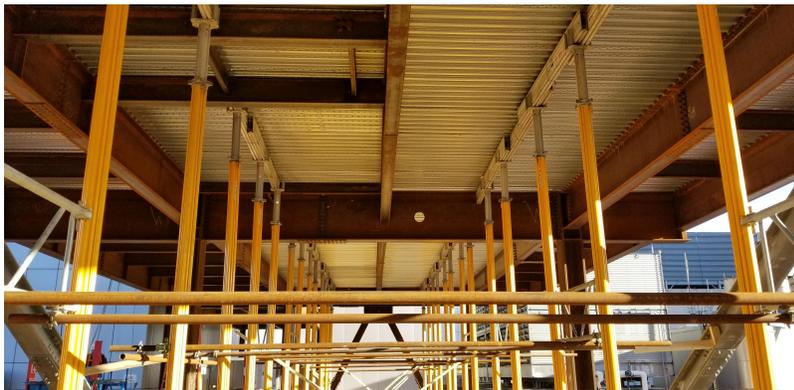
LEFT: DECK SHORING IN PLACE FOR 1ST SLAB ON METAL DECK POUR. DECK SHORING WAS USED INSTEAD OF ADDING AN ADDITIONAL BEAM TO REDUCE NUMBER OF PIECES THAT NEEDED TO BE TRANSPORTED UP THE MATERIAL HOIST.

- **Slab on Deck Design**: Every piece of steel that had to be moved on the material hoist cost money and time. During the pre-construction phase an effort to reduce piece count led to the removal of one infill beam in the 24' wide bay, resulting in a single infill beam and a 12' deck span. This required deck shoring when pouring the slabs on metal deck.
