# UNITED STATES CAPITOL VISITOR CENTER - DRILLED SHAFTS, UTILITY CONFLICTS, AND COMMUNICATION

Giovanni A. Bonita, PhD, PE, PG, Weidlinger Associates, Washington DC, USA

William Maher, McKinney Drilling Company, Pittsburgh, Pennsylvania, USA

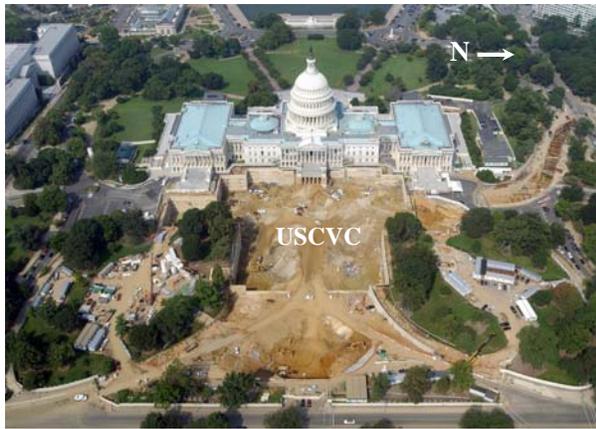
The USCVC structure is located on the eastern side of the existing U.S. Capitol building, immediately adjacent to its foundations (Figure 1). The main excavation support and water cut-off mechanism is a slurry (diaphragm) wall (Figure 1). Tiebacks were installed to support the wall during the temporary construction stages. Interior building columns were supported on drilled shafts.

Figure 1 – Site Location (courtesy of AOC)

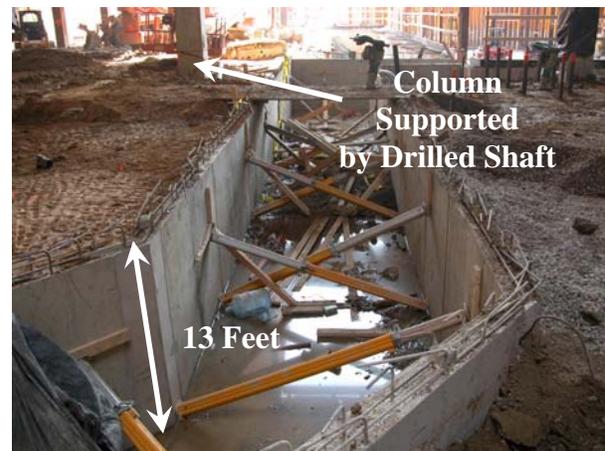
In order to optimize building space, the vast majority of the utilities were located beneath the basement floor slab (Figure 3). It was decided at the onset of the project to proceed with construction prior to completion of the design drawings. Coordination between the underslab utilities and drilled shafts had not yet been finalized at the beginning of the drilled shaft installation. Given the depth and location restrictions of the outlets, relocation of the bulk of the utilities was not possible. A majority of the drilled shafts were affected, leaving redesign as the most feasible remedial solution.

Figure 3 – Below-Slab Utility Trench

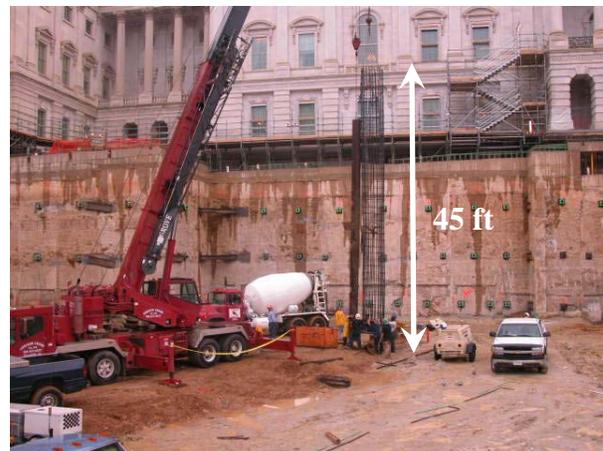
All drilled shafts were installed after the excavation had reached the service level (Figure 4). Drilled shafts ranged in diameter from 3.5 to 9.5 ft (1.1 to 2.9 m) and in length from 15 to 45 ft (4.6 to 13.7 m).

Figure 4 – Drilled Shaft Installation

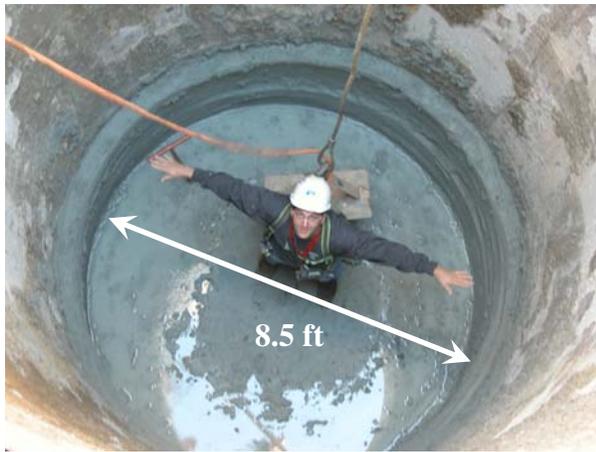
Due to the revised construction sequence, all holes were drilled in the dry, with the vast majority of holes terminating in the very stiff P3 clay soils. The subgrade of each drilled shaft was manually inspected to confirm the presence of competent soils (Figure 5). The presence of the design engineer on site essentially eliminated any delays associated with the down-hole inspection.

Figure 5 – Drilled Shaft Installation and Inspection

- 5- Down-hole inspection of the drilled shafts can serve as a useful quality assurance tool during drilled shaft installation, especially in belling operations where the bell diameter can vary and soil can pack at the bottom of the drilled shaft. Unqualified and inexperienced inspectors, however, can negatively affect project costs and schedule.

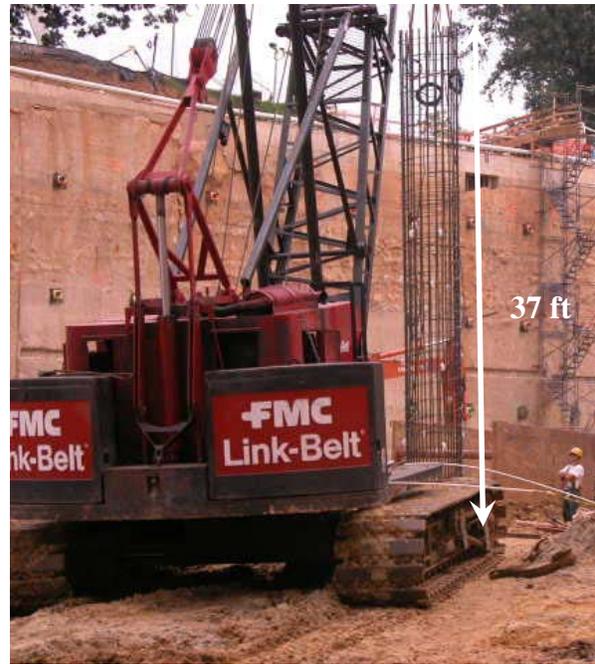
The shaft reinforcement was lowered into the hole using plastic guide wheels clipped every 2 feet (610 mm) along the length of the cage (Figure 6). The steel reinforcement was set 6 inches (152 mm) above the bottom and below the top of the drilled shaft. A 1% area-of-steel-to-area-of-concrete ratio was maintained for the steel rebar reinforcement.

Figure 6 – Drilled Shaft Reinforcement

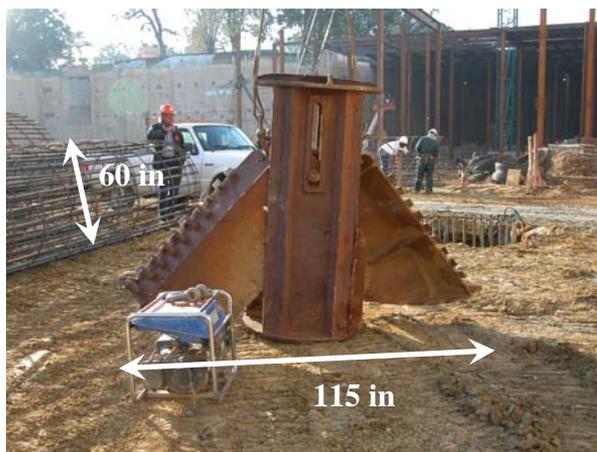
In several areas of the site, particularly in the northwest quadrant, the cuts for the utilities resulted in exposures of 33% to 75% of the shaft length. Length and diameter modifications of the drilled shafts, combined with the increased strength parameters, were inadequate to accommodate the design requirements. Bells were therefore added to the base of the drilled shafts to meet the design needs (Figure 11). Bells, with diameters ranging from 7 to 10 feet (2.1 to 3.1 m), were added on a case-by-case basis at the direction of the design engineer. A total of 34 drilled shafts, or 18% of the total, were modified to include bells (Figure 9).

Figure 11– Drilled Shaft Belling Tool
