# ***Lessons Learned From Structural Failures***

*Presented by:* **Clifford Schwinger, PE**

**October 15, 2019 DVASE Breakfast Presentation**

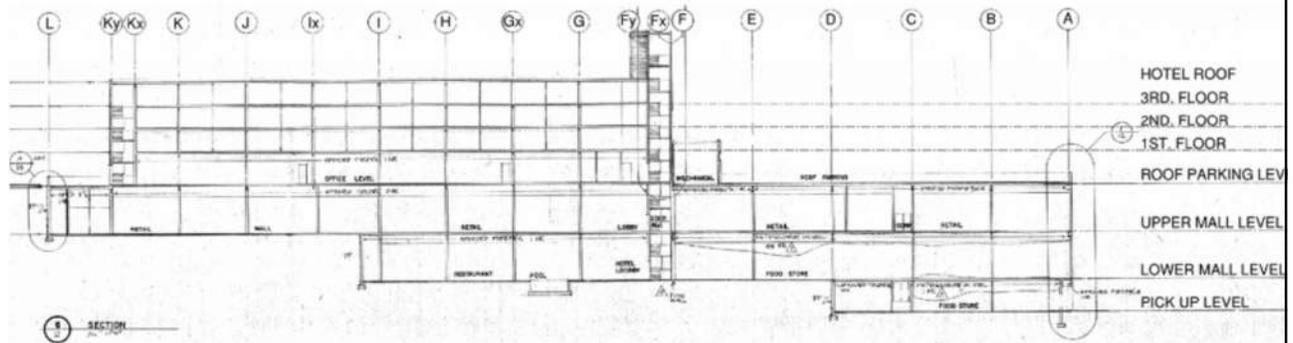
Figure 2-1 -Section View of Algo Centre Mall Looking North

- Three story steel-framed shopping mall & hotel w/ parking on roof
- 8" hollowcore plank on roof supported on steel framing. (Bad decision. Never use plank for a parking deck.)
- Plank specified to have 120 psf capacity (but 8" plank could not support 120 psf.)
- No waterproofing system on parking deck. (Topping slab, no membrane)
- Building plagued by roof leaks since new (1980).

- June 2012: Two bays collapse - killing two.
- Collapse caused by failure of corroded beam-to-column connection.

- March 2013: Forensic report issued. Collapse was caused by a failure of a welded connection due to corrosion. Corrosion caused by improper waterproofing and placement of parking deck on roof, which allowed salt-laden water to corrode the structure.
- Original engineer and architect testified they objected to the rooftop parking, but the owner did not listen.

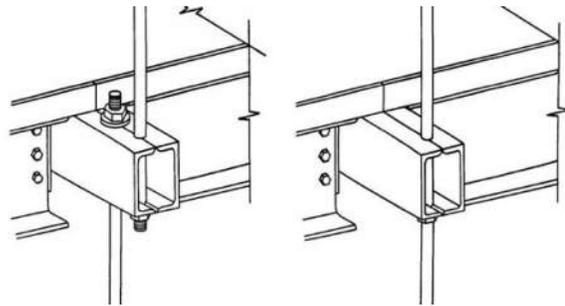
- December 1978: Contract awarded to fabricator
- January 1979: Fabricator's engineer requests change in hanger detail from one hanger to two via phone conversation with EOR. EOR agrees with concept but asks that request be forwarded formally "through channels". (Did not happen.)
