DVASE 2017 Excellence in Structural Engineering Awards Program

Approximate construction cost of facility submitted:	\$6.8 million	\$2.3 m – Phase I \$4.5 m – Phase II
Name of Project:	Carnegie Lake Dam Structural Repairs and Maintenance	
Location of Project:	Princeton, Mercer County, New Jersey	
Date construction was completed (M/Y):	November 2016	
Structural Design Firm:	Joseph B. Callaghan, Inc.	
Affiliation:	All entries must be submitted by DVASE member firms or members.	
Architect:	NA	
General Contractor:	Kyle Conti Construction, LLC

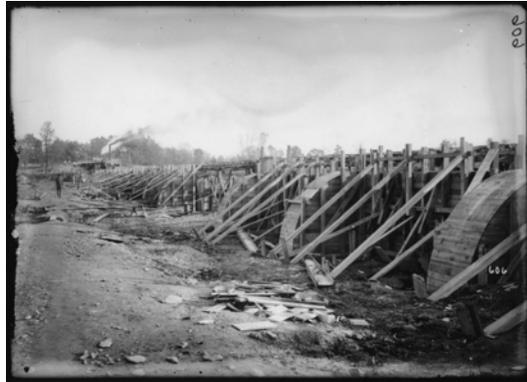
Photo courtesy of Princeton University Archives

Carnegie Lake Dam is a 724 foot long, concrete buttress dam structure consisting of three major structural components; 1) Buttress supported concrete wall spillway, 2) Low level outlet structure and 3) Abutment walls (See Photos No. 1 & 2).

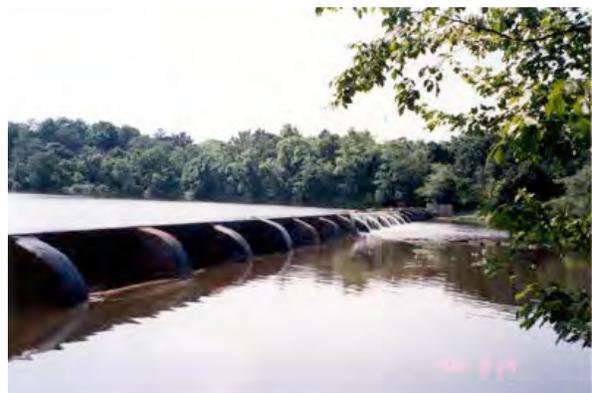
Plan of Carnegie Lake Dam

The west end of the dam consists of a 54 foot by 4 or 6 foot wide 'L' shaped concrete abutment extending out from the shoreline bank. The main dam spillway is a 575 foot long buttress supported concrete wall bounded by the east outlet structure and west abutment wall. In the center of the spillway there is a 193 foot long V-notch weir section that has a center depth of approximately 0.7 feet. The upstream face of the concrete wall consists of an interlocking steel sheet piling wall.

The east end of the dam consists of the low level outlet structure and a concrete abutment wall. The low level outlet structure is located west of the abutment wall separated by a continuation of the spillway. The outlet structure is a 12 foot long concrete structure that contains two 42"+ diameter cast iron pipes. A 20 inch thick concrete slab spans between the east end abutment wall and the outlet structure providing walkway access from the east abutment. The east end abutment wall is approximately 52 foot long by 6 foot wide concrete abutment wall curved inward on the downstream side. The east abutment wall abuts the Delaware-Raritan Canal embankment.

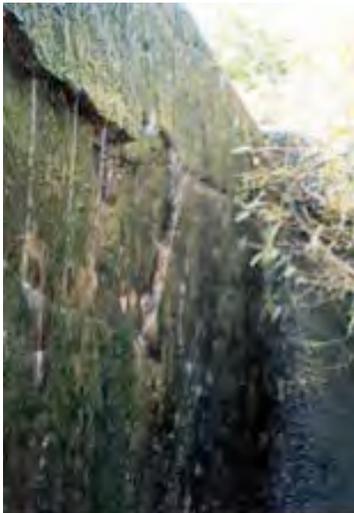
Cracking and deterioration in gunite overlay along buttress wall.

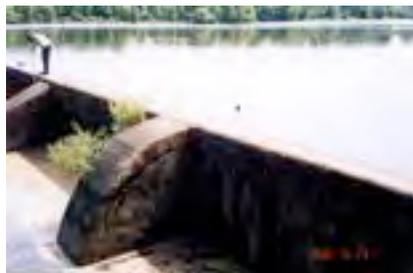
Cracking and deterioration along concrete buttress. Vegetation growth extending from buttress.

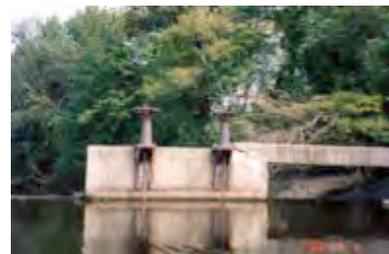
Cracking with concrete spalling at outlet control structure.

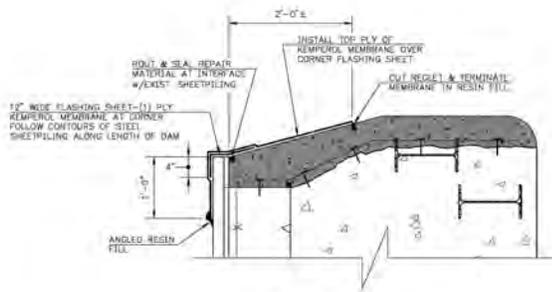
DETAIL A/S-6B
WATERPROOFING DETAIL AT TYPE 3 REPAIR
 SCALE: 1" = 1'-0"

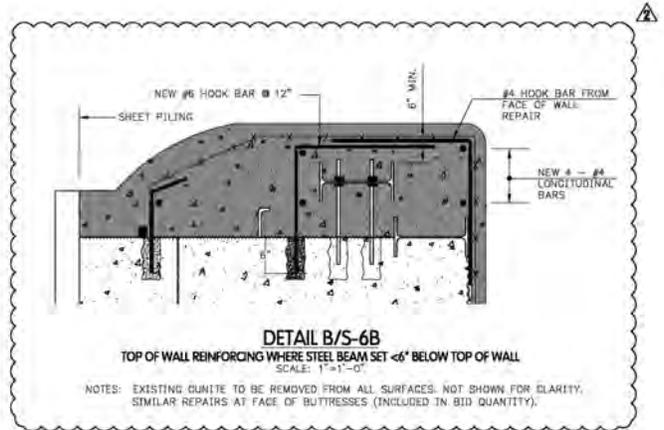
DETAIL B/S-6B
TOP OF WALL REINFORCING WHERE STEEL BEAM SET 6" BELOW TOP OF WALL
 SCALE: 1" = 1'-0"
 NOTES: EXISTING CURB TO BE REMOVED FROM ALL SURFACES; NOT SHOWN FOR CLARITY. SIMILAR REPAIRS AT FACE OF BUTTRESSES (INCLUDED IN BID QUANTITY).
