DVASE 2021 Excellence in Structural Engineering Awards Program

Approximate construction cost of facility submitted:	\$660,000
Name of Project:	Uncommon School 571 18th Avenue School
Location of Project:	Newark, NJ
Date construction was completed (M/Y):	September 2019
Structural Design Firm:	Joseph B. Callaghan, Inc.
Affiliation:	All entries must be submitted by DVASE member firms or members.
Architect:	KSS Architects
General Contractor:	Phelps Construction Group

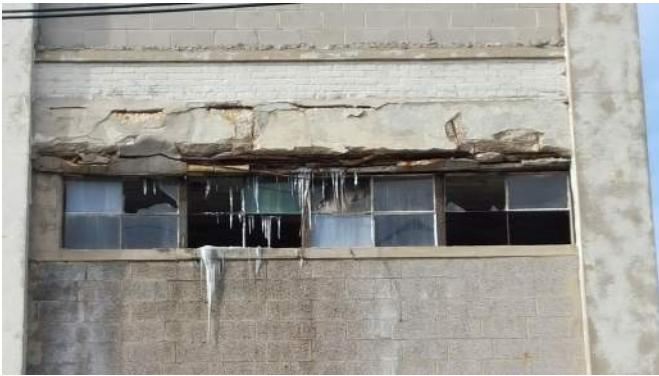
571 18th Avenue Concrete Repair Progress

Repair Status		
Elevation	Beam	Concrete Demolition	Rebar & Anode Placement	Coat Reinf. & Patch
North	N-A1	Complete	Ready	Not Permitted
	N-A2	Complete	Ready	Not Permitted
	N-A3	Not Yet Started	Not ready	Not Permitted
	N-A4	Incomplete	Not ready	Not Permitted
	N-B1	Incomplete	Not ready	Not Permitted
	N-B2	Complete	Ready	Not Permitted
	N-B3	Incomplete	Not ready	Not Permitted
	N-B4	Incomplete	Not ready	Not Permitted

Elevation	Beam	1 (LF)	2 (LF)	3 (LF)	4 (LF)	5 (SF)
North	N-A1		8		2	
	N-A2				10	
	N-A3					
	N-A4		9			
	N-B1		10	10		
	N-B2			10	10	
	N-B3					
	N-B4		3			1
<hr/>						
<hr/>						
<hr/>						
Total Quantities		0	0	89	82	126
Bid Quantities		0	125	175	175	225
Remaining Balance		0	125	86	93	72

When demolition began, it quickly became clear that the damage was far worse than the design team had anticipated. It also became clear that the condition of each concrete beam was unique, and each beam required a combination of multiple repair details. It was important that we evaluate each beam, developing a spreadsheet to track the status, repair type and quantity at each step of the repair process before we could authorize it to be formed and repaired.
