## DVASE 2019 Excellence in Structural Engineering Awards Program

Approximate construction cost of facility submitted:	Undisclosed
Entry Fee:	<b>FREE</b>
Name of Project:	Private Residence
Location of Project:	<u>Avalon, New Jersey</u>
Date construction was completed (M/Y):	03/2019
Structural Design Firm:	Mulhern and Kulp Residential Structural Engineering
Affiliation:	<b>All entries must be submitted by DVASE member firms or members.</b>
Architect:	Blaine Steinman Architects
General Contractor:	<u>Stonewood Builders, LLC</u>

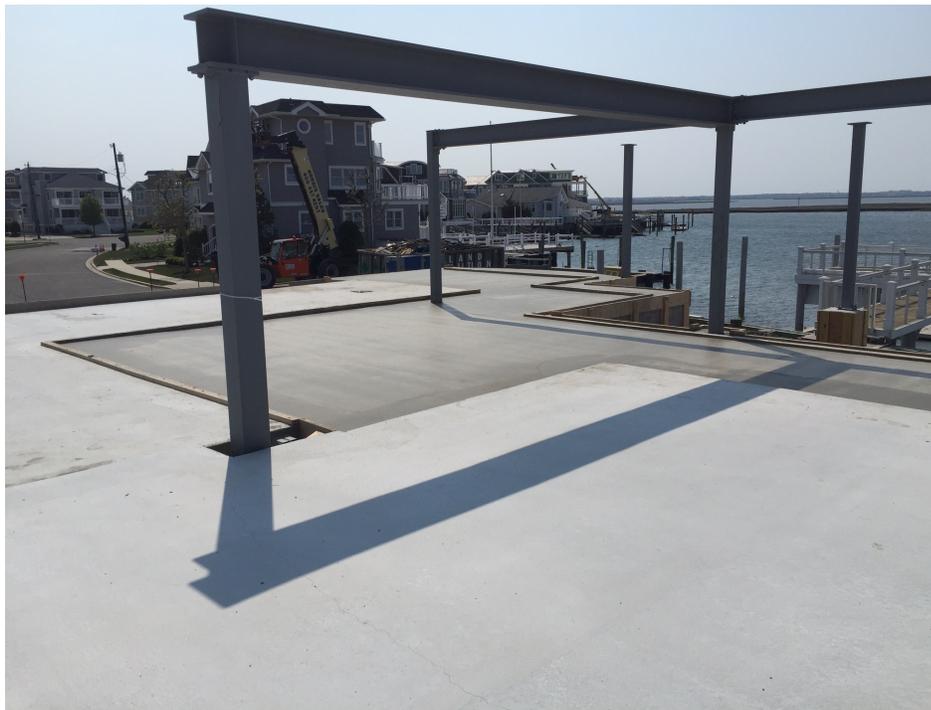
*Large steel beams & moment frames in the family room/Veranda to allow for the back of the house to open up to the bay*

This home was constructed with a variety of materials including wood, steel, masonry, and concrete. The home owner specifically requested all deflection requirements to be “doubled” for his floor framing to ensure a very rigid floor with minimal “bounce”. Thus, the code-allowable total load floor deflection requirement of  $L/360$  was increased to  $L/720$ . This drove the design of the main level floor framing to be a reinforced concrete slab on steel beams and reinforced CMU piers. The home owner also wanted maximum head height underneath the main level for storage purposes, which lead to W6x steel beams to be spaced at 24” o.c. to support the reinforced concrete slab. The upper level interior spaces were framed with a mix of i-joists and LVL floor joists, while exterior decks were framed with solid sawn joists. The “drive-under” foundation was built with reinforced CMU piers and CMU foundation walls located on reinforced concrete grade beams supported by driven timber piles. Large steel girders spanned long lengths at the 2<sup>nd</sup> floor framing plan to accommodate the roll-down screens and nanawalls which serve to open the entire rear of the house up to the views of the bay.

At all levels, many of the shear transfer details needed to be customized around the unique layout and architectural features. A combination of wood-framed shear walls and steel moment frames were used in resisting the design lateral forces of this home. The majority of the shear walls needed to be located on the interior of the home accommodated by unique shear transfer details and hold-downs. Large glass openings and wide-open floor plans required the use of multiple steel moment frames to resist the lateral forces.

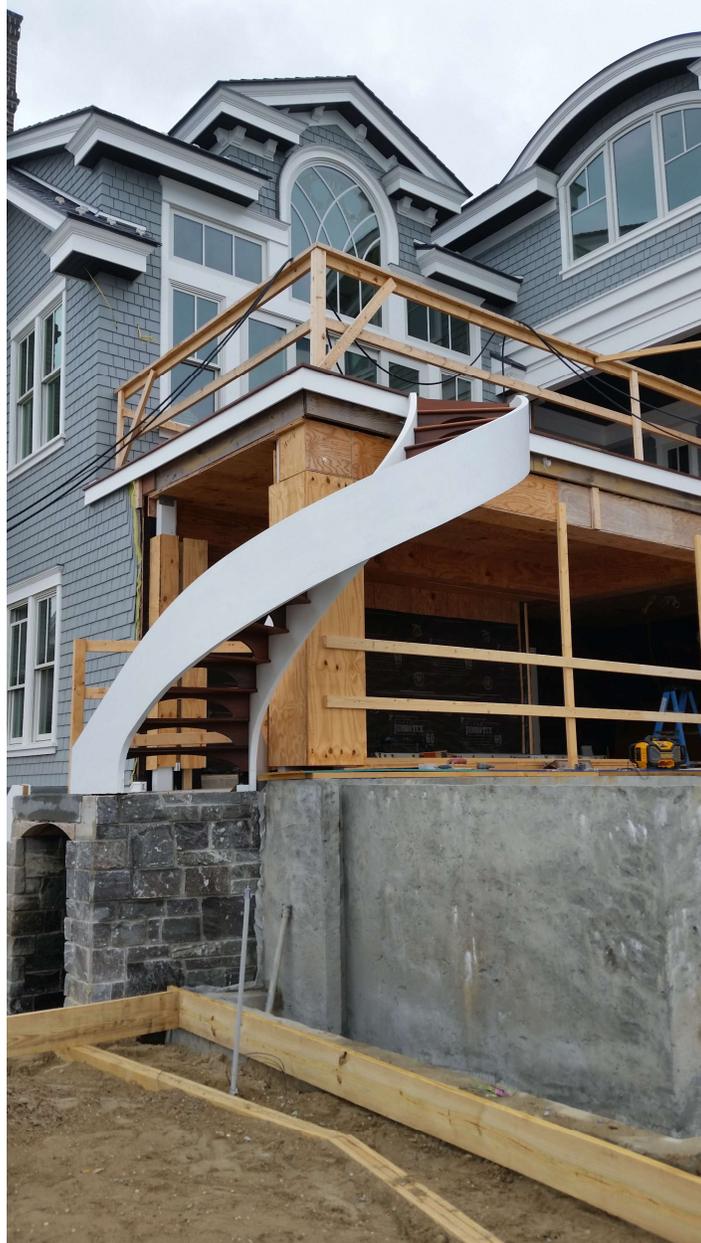
*Curved wooden stair stringers at rear deck*

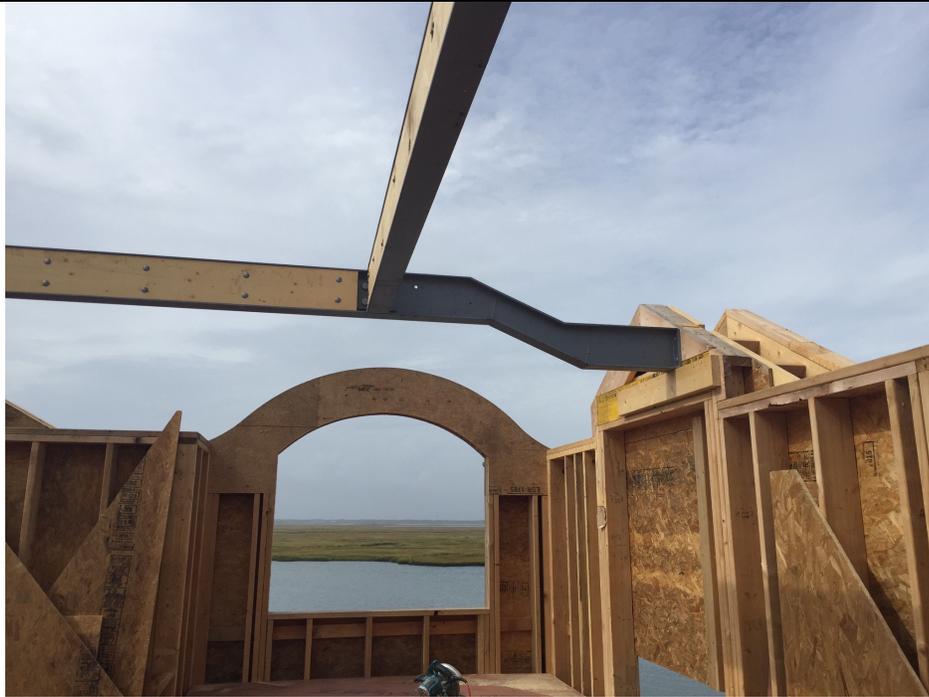
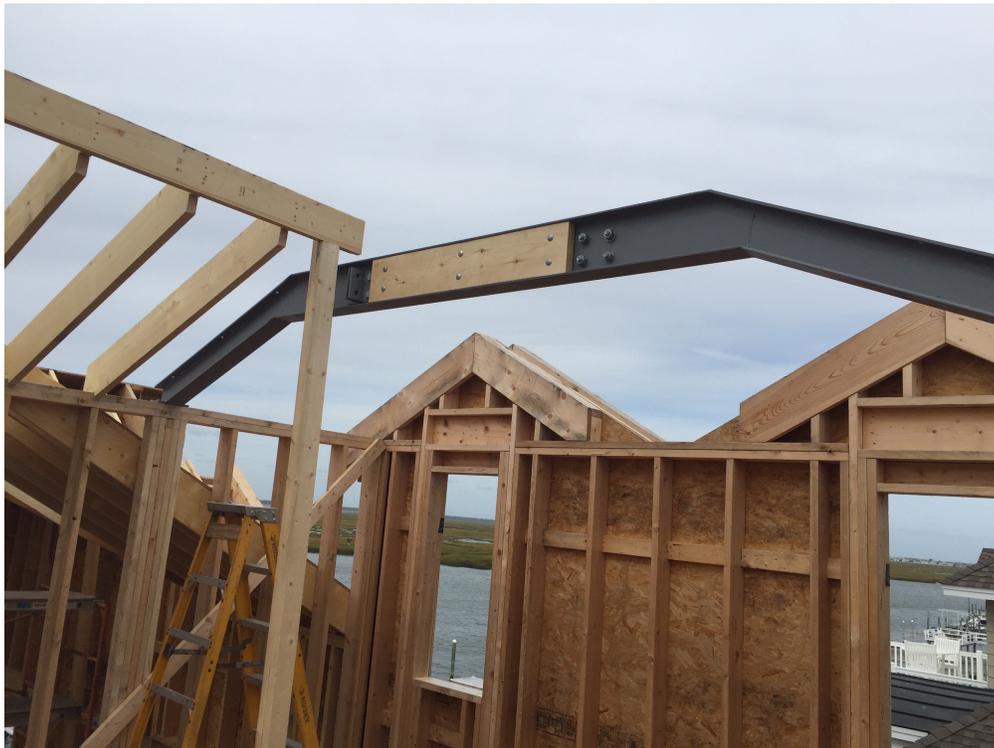
*Mitered steel beams at the roof framing*

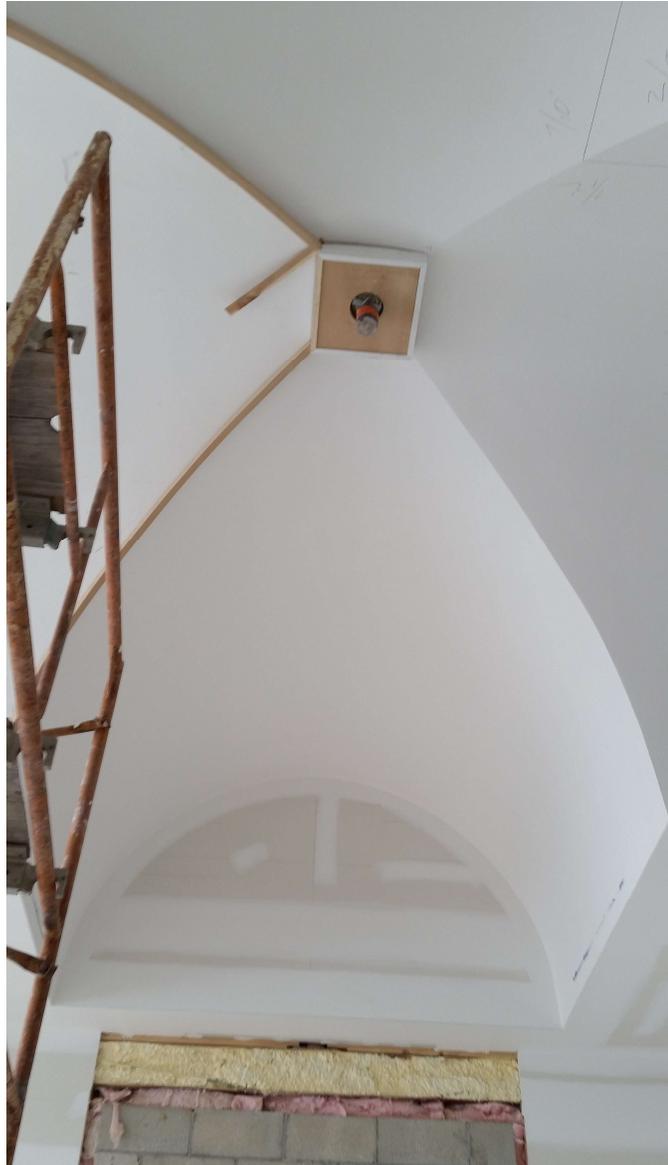
*Double barrel vaulted Ceiling in the Family Room with steel plates bolted to the ridge beam to support a chandelier*
